PROGRESS REPORT 1

REPORTING PERIOD: AUGUST 31, 2012-APRIL 30, 2013

RIVGEN™ POWER SYSTEM COMMERCIALIZATION PROJECT

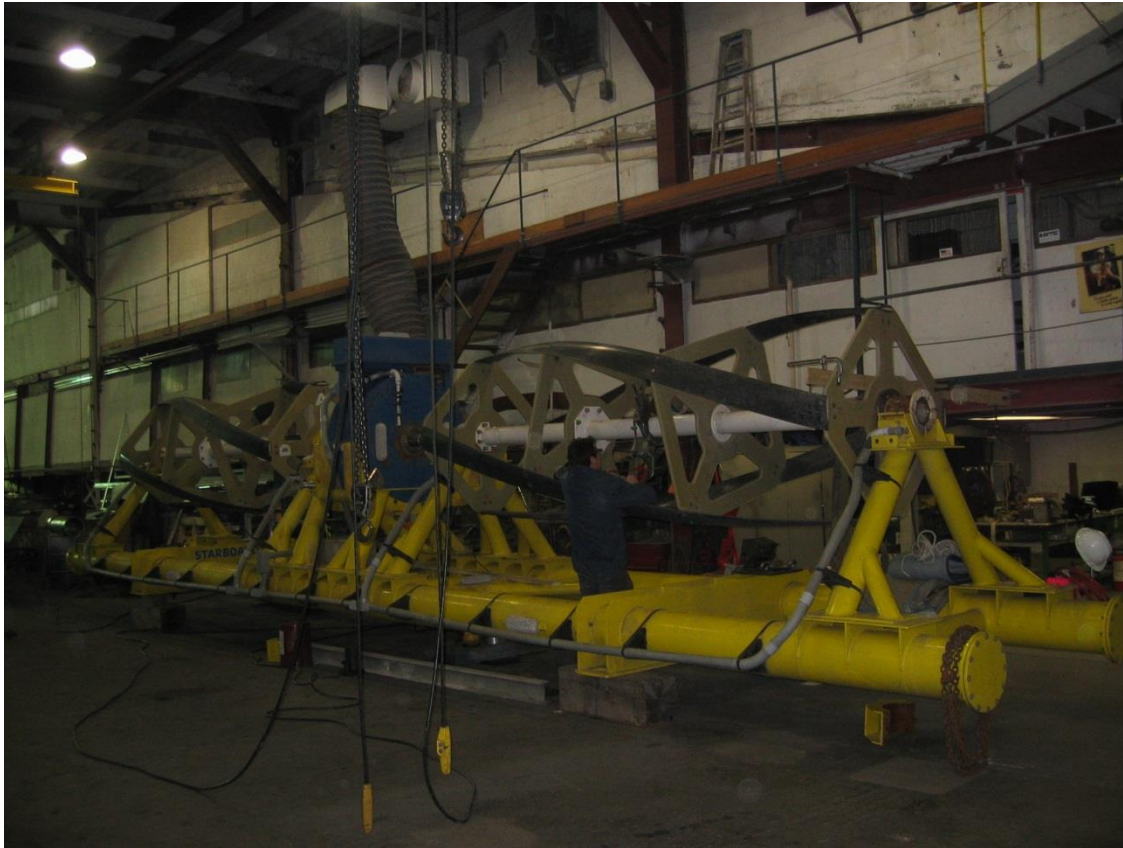
Figure 1. RivGen™ TGU sitting level on the mounting pads in the “baseline” configuration.

1. To complete a root-cause analysis of frictional resistance in the RivGen™ TGU. This involved several weeks of testing the RivGen™ TGU with various loads applied to its driveline and chassis. BluSource delivered the final report on the findings of the Phase 1 analysis work to ORPC On March 11, 2013; it was accepted by ORPC.
